Testing of State Roadside Safety Systems Volume XI: Appendix J— Crash Testing and Evaluation of Existing Guardrail Systems

PUBLICATION NO. FHWA-RD-98-046

1. Report No. FHWA-RD-98-046		2. Government Accession No.	
4. Title and Subtitle TESTING OF STATE ROADSIDE SAFETY SYSTEMS VOLUME XI: APPENDIX J - CRASH TESTING AND EVALUATION OF EXISTING GUARDRAIL SYSTEMS		5. Report Date April 1999

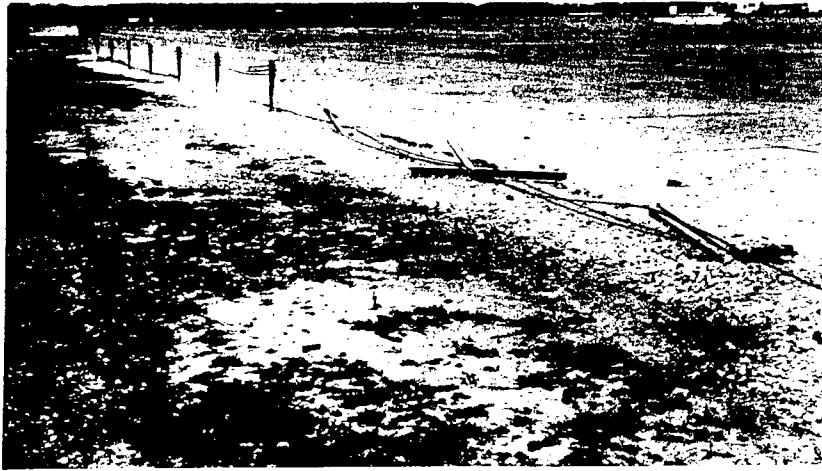
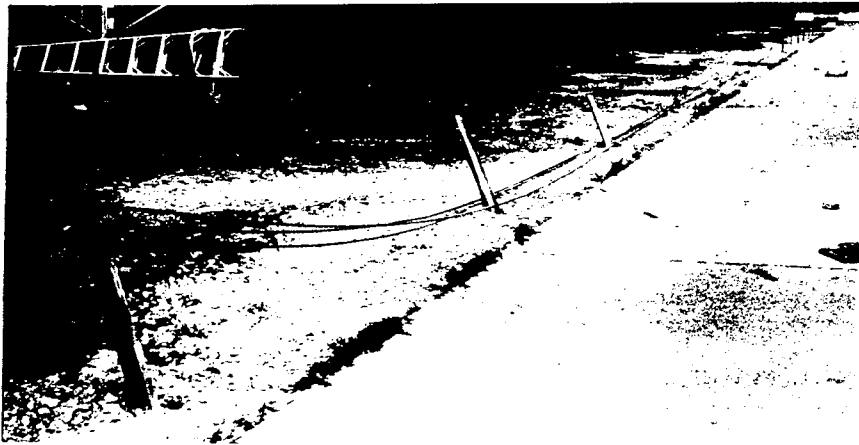
As seen in figures 16 and 17, the test installation received moderate damage. The cables were separated from the posts between posts 10 through 16. The lateral deflections recorded at posts 8 through 16 are noted in table 2.

Figure 16. Cable (G1) guardrail installation after test 471470-28.

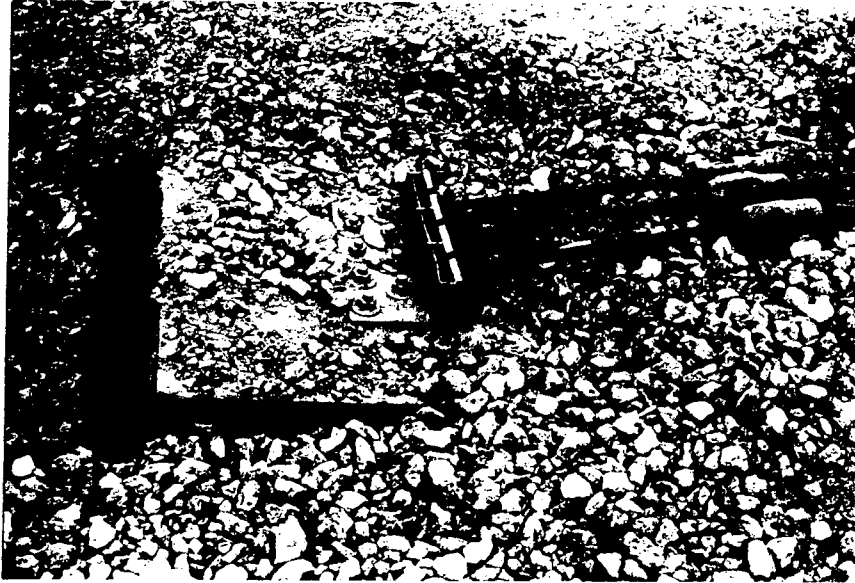
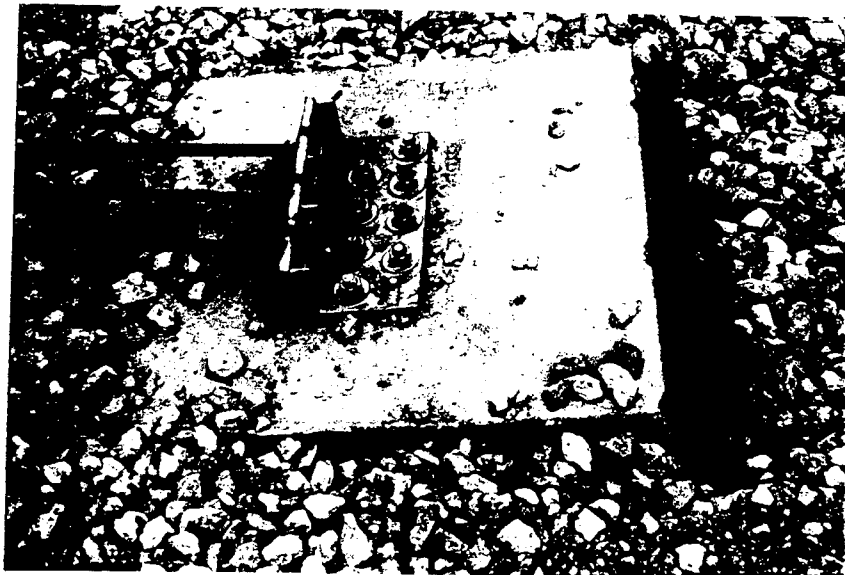
Figure 17. Anchor for the cable (G1) guardrail after test 471470-28.

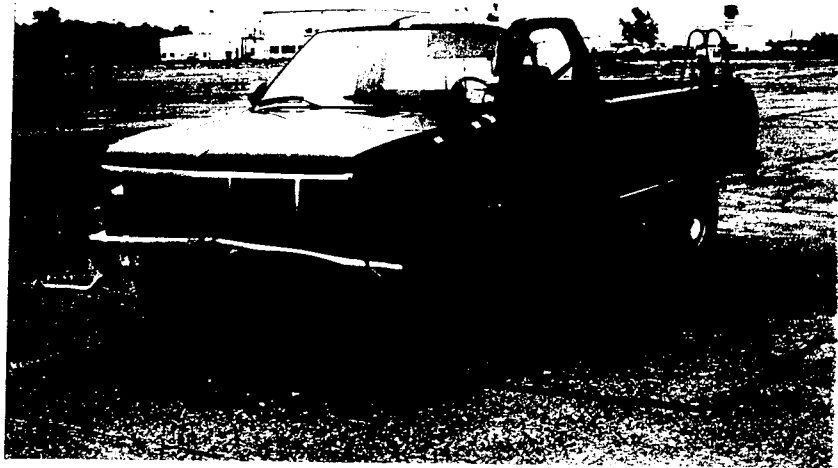
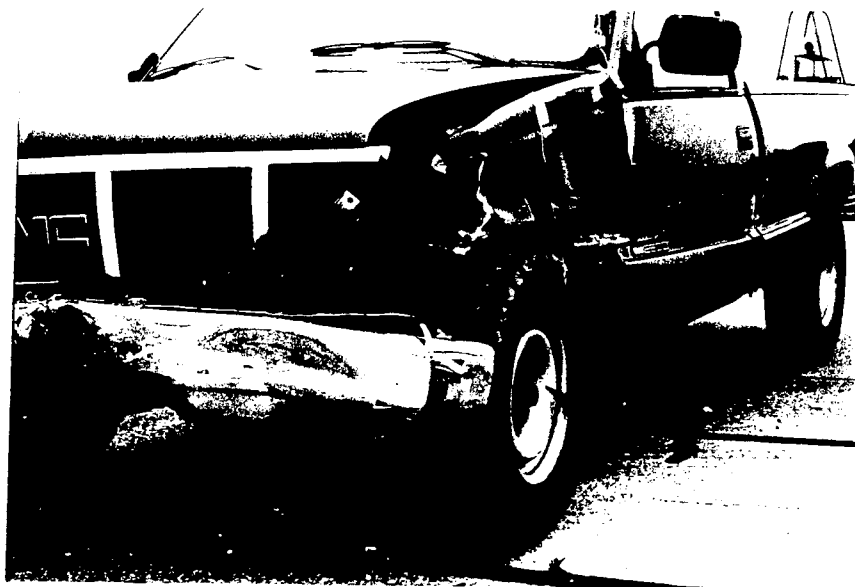
The vehicle sustained minimal damage, as shown in figure 18. The front bumper and grill were damaged, and the entire left side of the vehicle was scraped by the wire rope. Maximum exterior crush at the left front corner of the vehicle was 360 mm (14.2 in), and there was no deformation or intrusion into the occupant compartment.

Figure 18. Vehicle after test 471470-28.

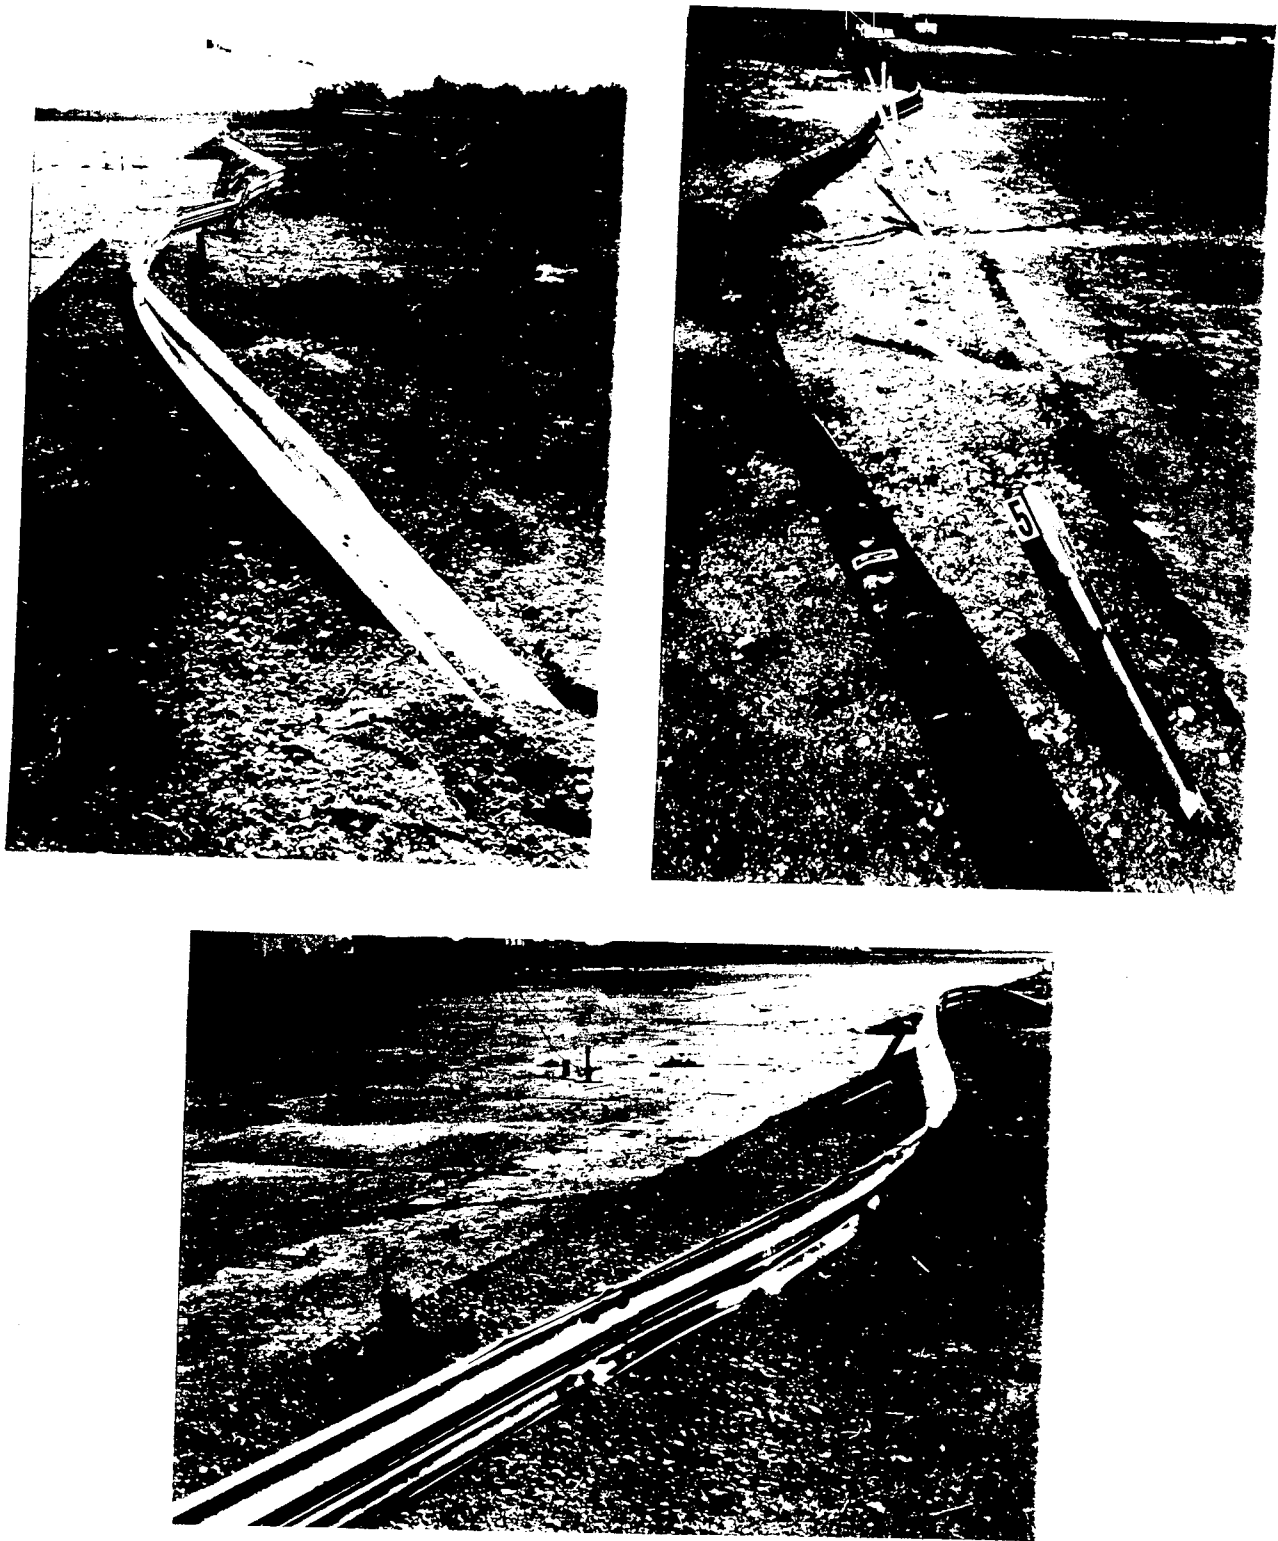
Figure 31. W-beam, weak-post (G2) guardrail after test 471470-21.

As can be seen in figure 31, the test installation received considerable damage. There was evidence of movement on all of the posts and the W-beam slipped over the tops of post 5 through 13 and the maximum permanent deformation of the W-beam was 1.8 m (5.9 ft). The vehicle was in contact with the installation from impact to the end of the guardrail.

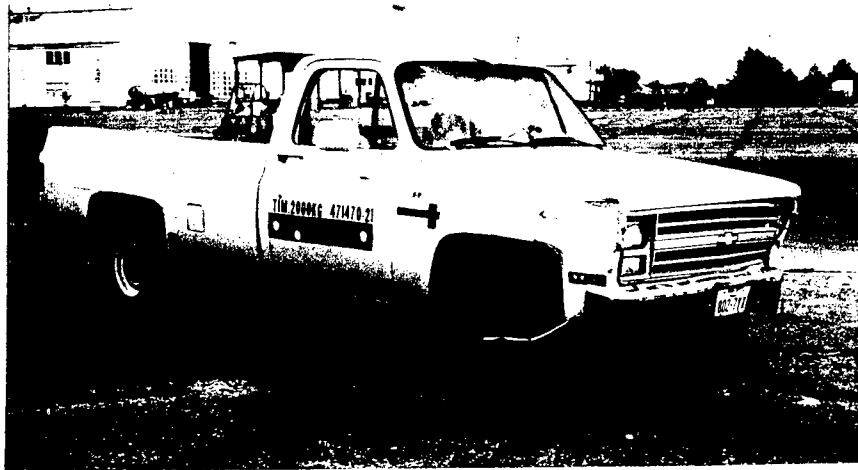
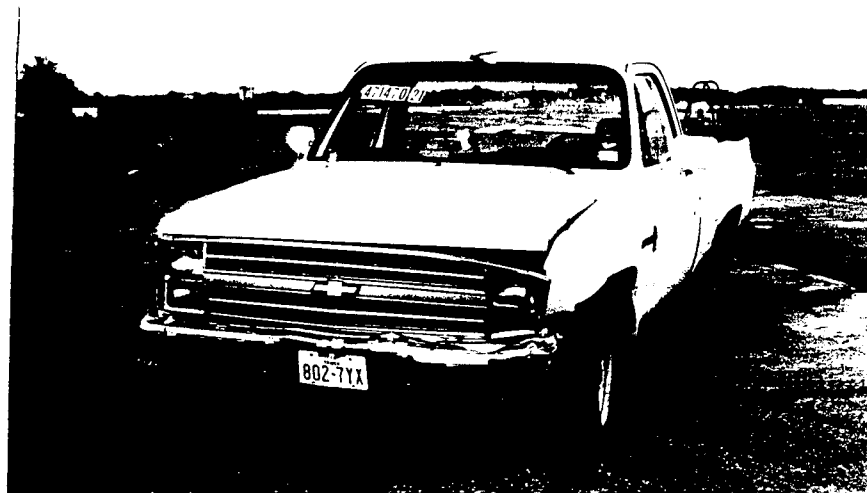
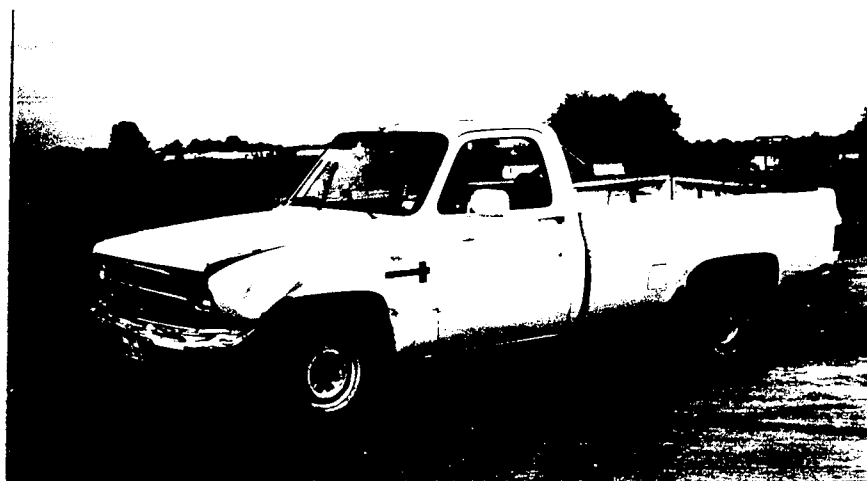
Figure 32. Vehicle after test 471470-21.

The vehicle sustained moderate damage to the left side as shown in figure 32. Maximum exterior crush at the left front corner at bumper height of the vehicle was 259 mm (10.2 in), and there was no intrusion into or deformation of the occupant compartment. Damage was sustained to the front bumper, grill, hood, and along the entire left side the body panels were dented and scraped. There was slight damage to the right front corner where the vehicle came to rest against the next installation downstream.

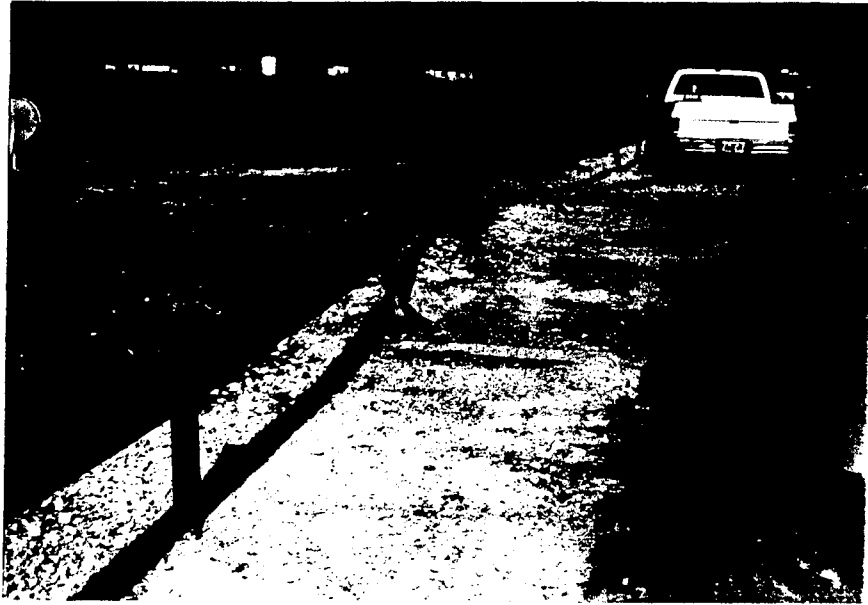
Figure 44. W-beam, weak-post (G2) guardrail after test 471470-22.

As can be seen in figures 44 and 45, the guardrail installation received considerable damage in the area of contact. There was evidence of movement on the first 9 posts. The W-beam slipped over the tops of posts 5 through 7 and the maximum permanent deformation of the W-beam was 1.3 m (4.2 ft). The vehicle was in contact with the installation for a total length of 15.7 m (51.7 ft).

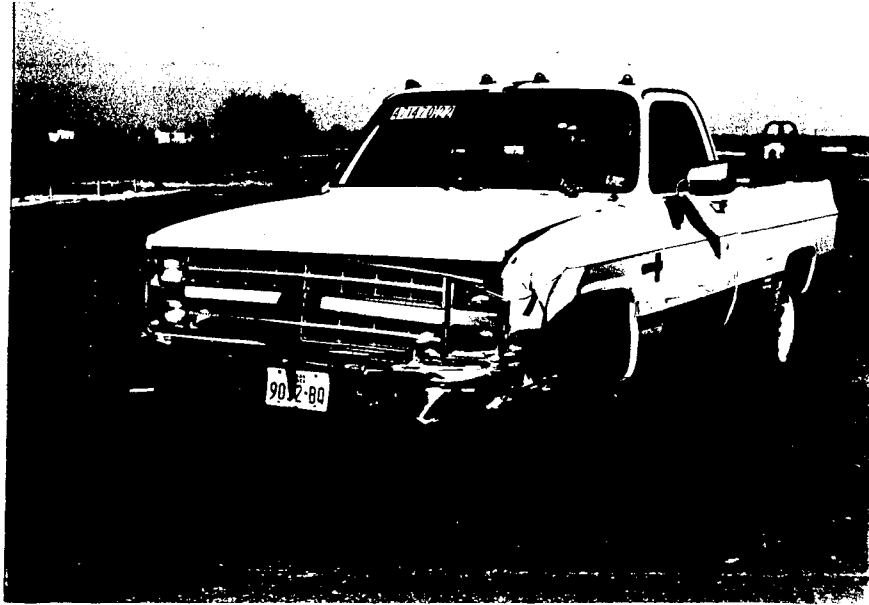
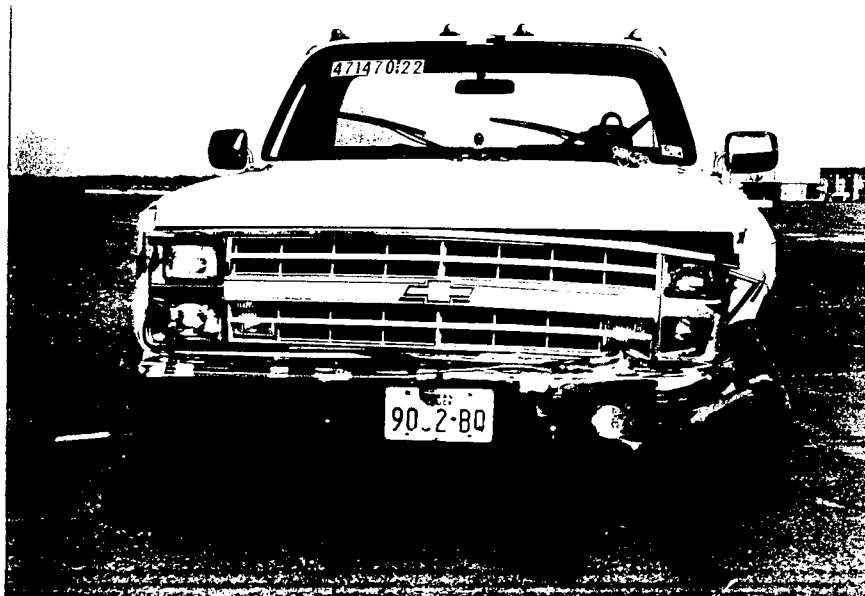
Figure 45. Vehicle after test 471470-22.

The vehicle sustained moderate damage to the left side, as shown in figure 46. Maximum exterior crush at the left front corner at bumper height of the vehicle was 231 mm (9.1 in), and there was no intrusion into or deformation of the occupant compartment. Damage was sustained to the front bumper, grill, hood, left front lower A-arm assembly, and along the left side the body panels were dented and scraped through the driver's door.

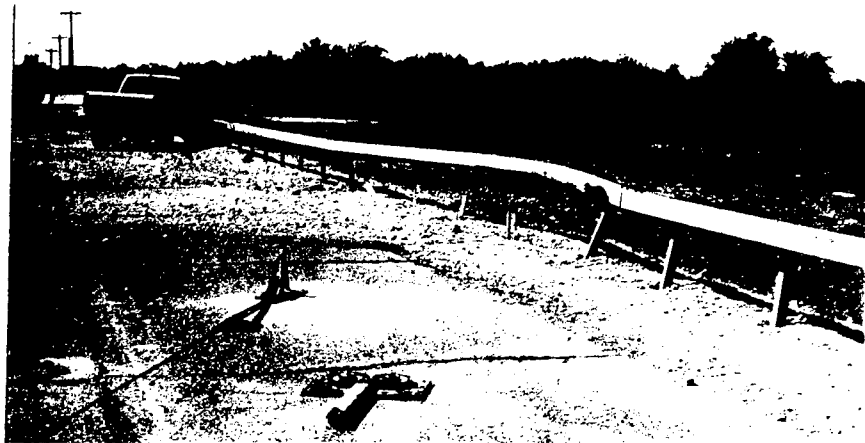
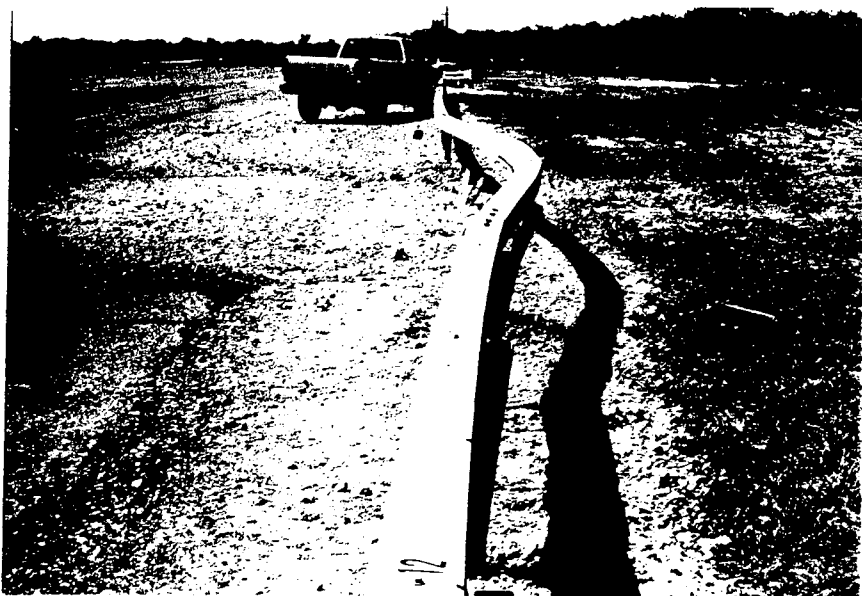
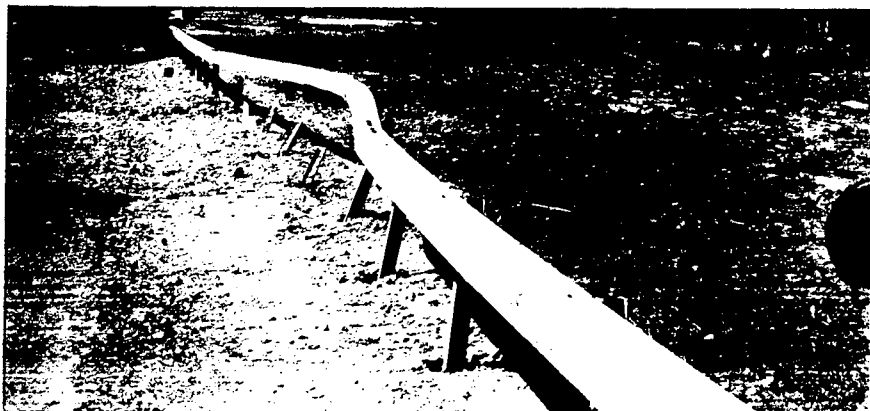
As seen in figures 59 through 61, the guardrail installation received moderate damage. There were tire marks on the face of the box-beam rail element from posts 15 through 21, and on posts 15 through 20. The box-beam rail element was separated from posts 16 through 20, and these posts were bent at ground level. The lateral deflections recorded at posts 12 through 22 are noted in table 3.

Figure 59. Box-beam (G3) guardrail after test 471470-33.

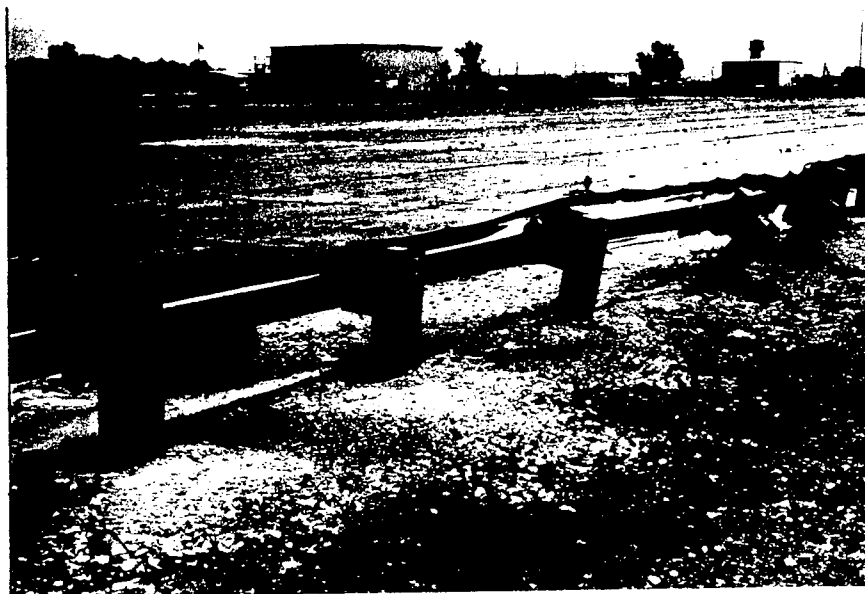
Figure 75. W-beam, wood-post (G4(2W)) guardrail installation after test 471470-26.

As can be seen in figures 75 and 76, the installation received moderate damage. The bolts were pulled out of the W-beam rail element at posts 15 and 16, and the blockout on post 16 was split. None of the posts broke off, but some posts were pushed back. The displacements of the posts are shown in table 4.

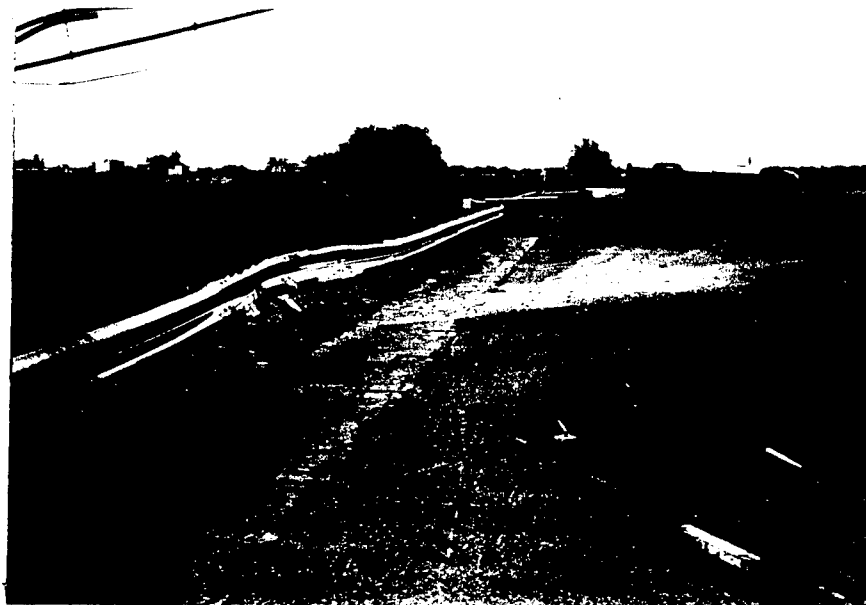
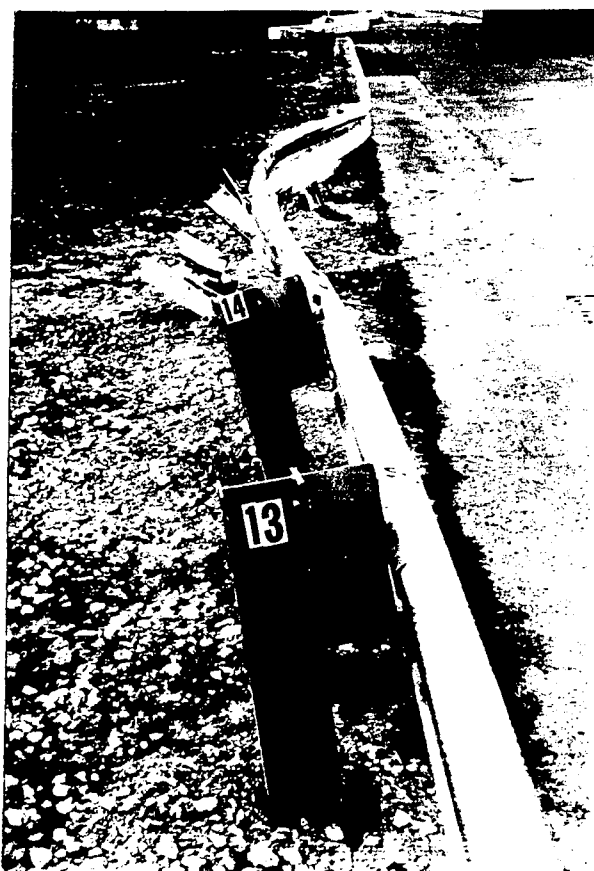
Figure 90. W-beam, steel-post (G4(1S)) guardrail installation after test 471470-27.

As can be seen in figures 90 and 91, the installation received moderate damage. The MELT anchor on the upstream end had pulled up slightly and moved laterally 44.5 mm (1.75 in). The buffered end nose was pulled off the end post (post 1). The bolts were pulled out of the W-beam rail element at posts 15, 16, and 17, and the posts and blockouts were bent. All the steel posts upstream of impact were disturbed, with measurable displacements as shown in table 5.

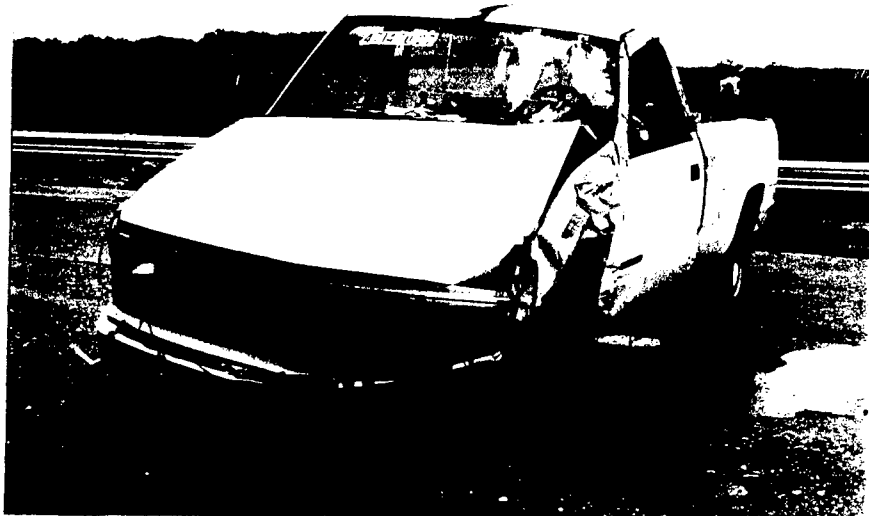
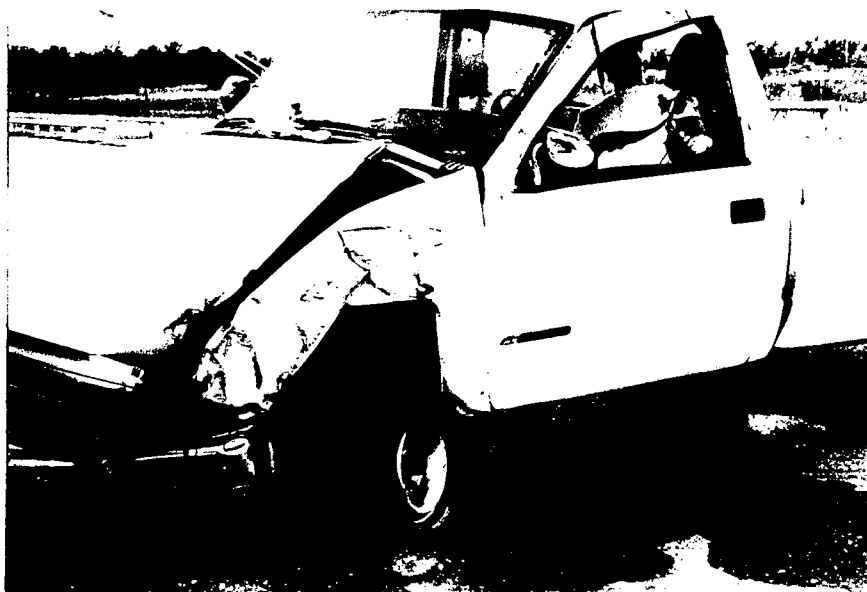
Figure 93. Vehicle after being uprighted, test 471470-27.

The vehicle sustained moderate damage, as shown in figures 92 and 93. The stabilizer bar, upper and lower A-arms, and tie rods on the left side were damaged, and the frame at the left front was bent. The left front spindle, wheel, and tire were damaged. The front bumper, grill, hood, radiator, windshield, and entire left side also were damaged. Maximum exterior crush at the left front corner of the vehicle was 570 mm (22.4 in) at bumper height. There was 53-mm (2.1-in) deformation of the occupant compartment in the floor pan area on the driver's side.

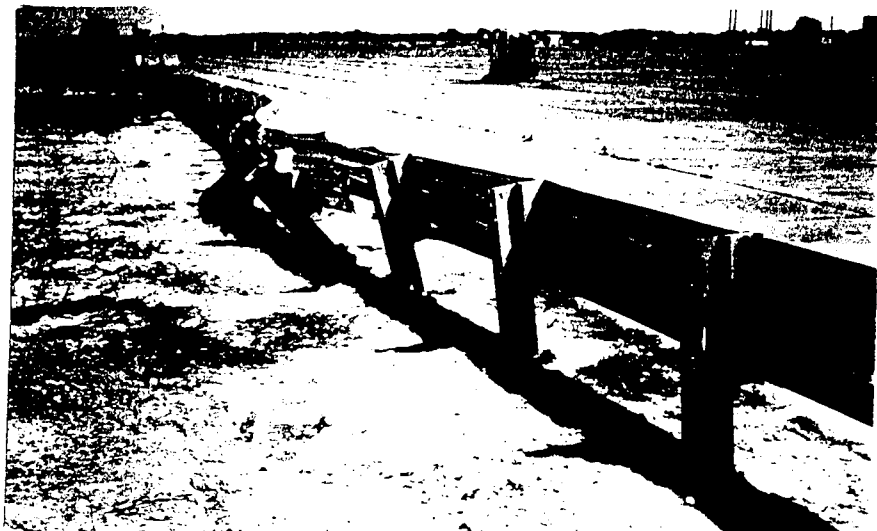
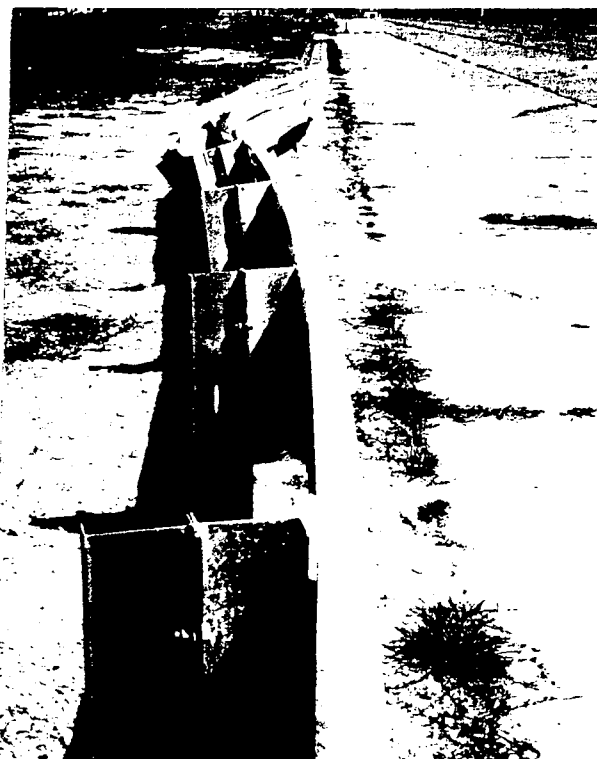
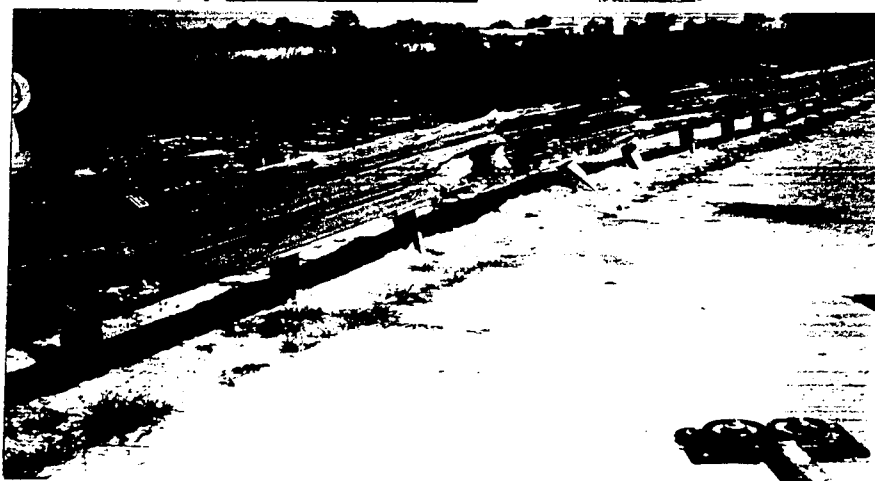
Figure 107. Three-beam guardrail after test 471470-31.

As seen in figures 107 through 109, the test installation received moderate damage. There were tire marks on the face of the thrie-beam rail element from post 15 through post 19, and on the face of posts 16 and 17. The thrie-beam rail element was separated from post 16, and the flanges on post 17 showed evidence of wheel contact. Posts 15 through 19 were twisted severely. The lateral deflections recorded at posts 13 through 20 are noted in table 6.

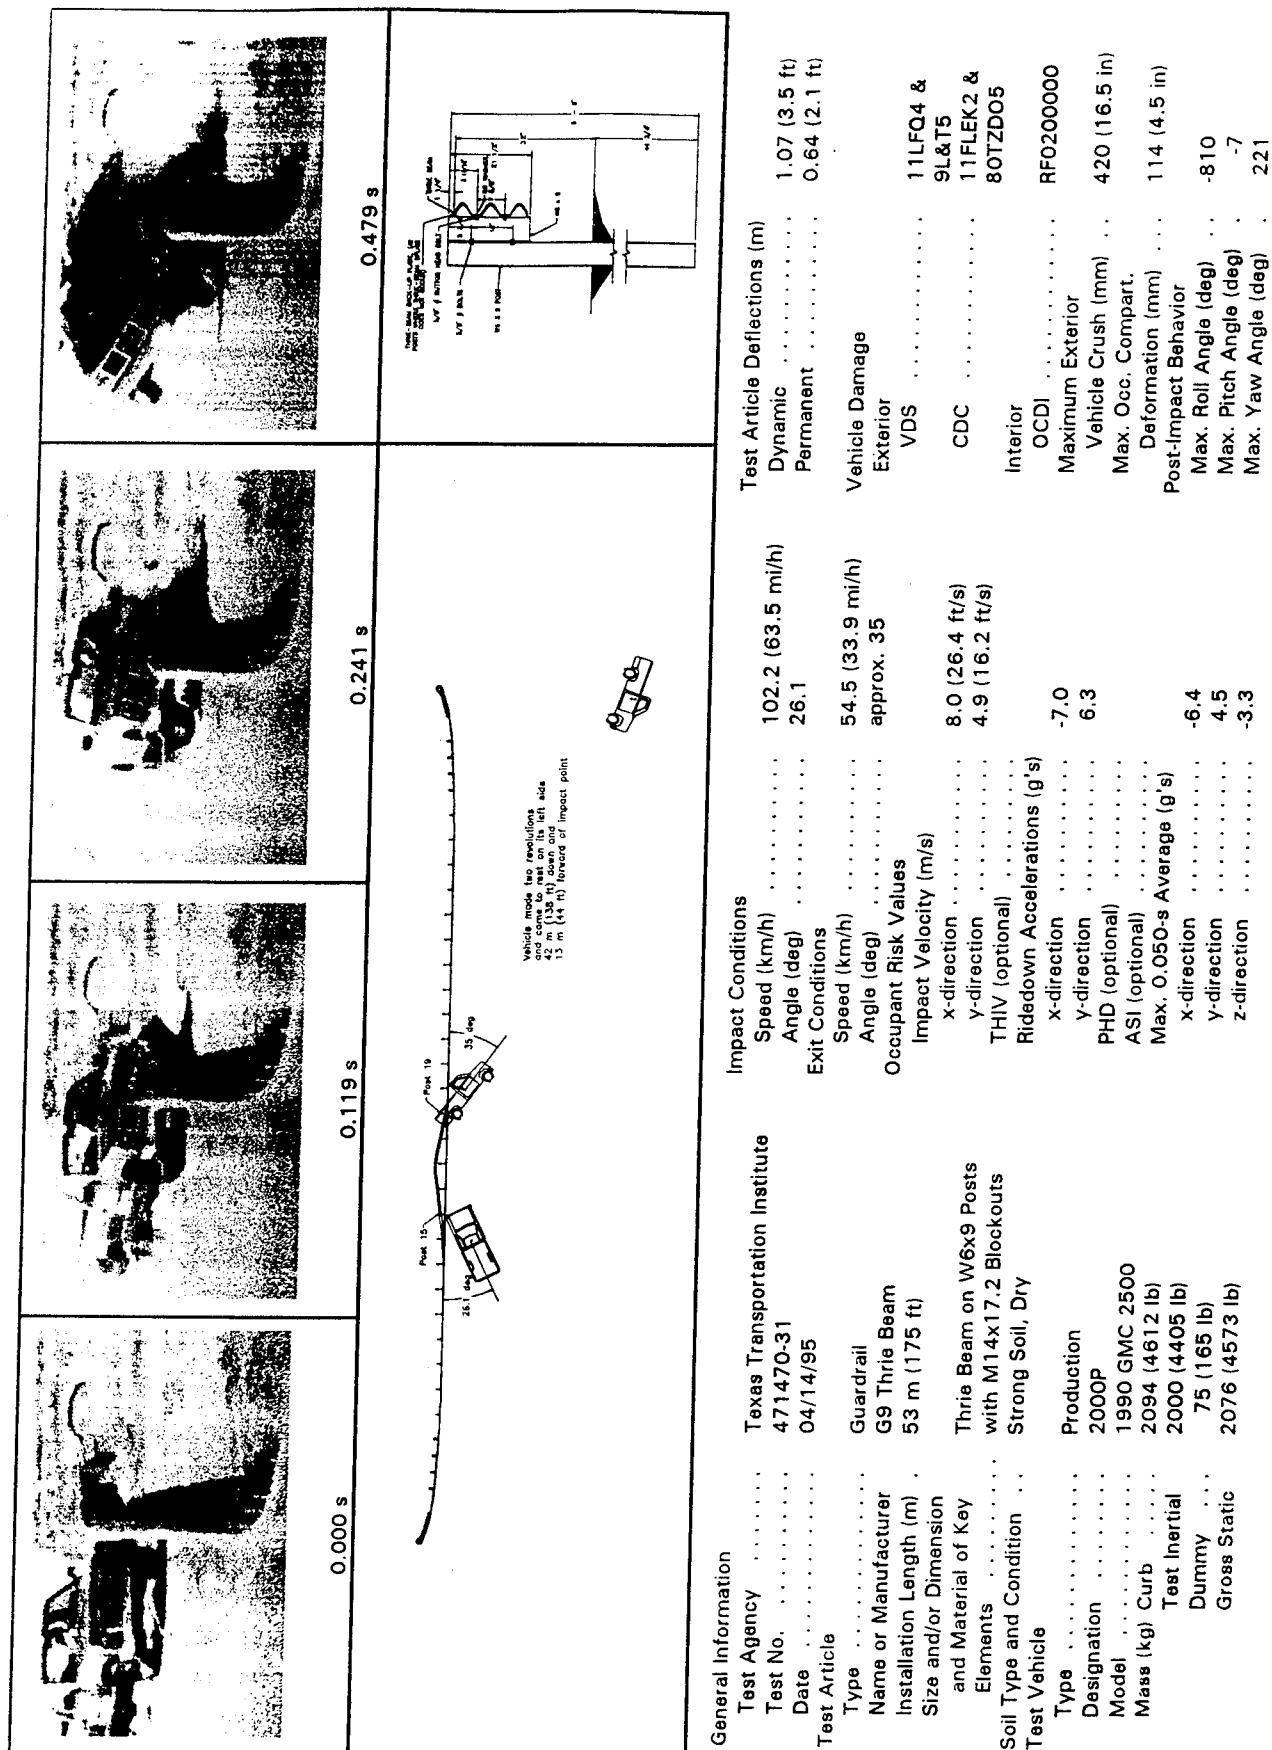
Figure 111. Summary of results for test 471470-31.

Data from the accelerometer located at the vehicle center of gravity were digitized for evaluation of occupant risk and were computed as follows. Occupant contact first occurred in the lateral direction. Lateral occupant impact velocity was 4.9 m/s (16.2 ft/s) at 0.145 s, the highest 0.010-s lateral occupant ridedown acceleration was 6.3 g between 0.185 and 0.195 s, and the maximum 0.050-s average acceleration was 4.5 g between 0.161 and 0.201 s. In the longitudinal direction, the occupant impact velocity was 8.0 m/s (26.4 ft/s), the highest 0.010-s occupant ridedown acceleration was -7.0 g between 0.179 and 0.189 s, and the maximum 0.050-s average was -6.4 g between 0.142 and 0.192 s. These data and other information pertinent to the test are summarized in figure 111. Vehicle angular displacements during the test are displayed

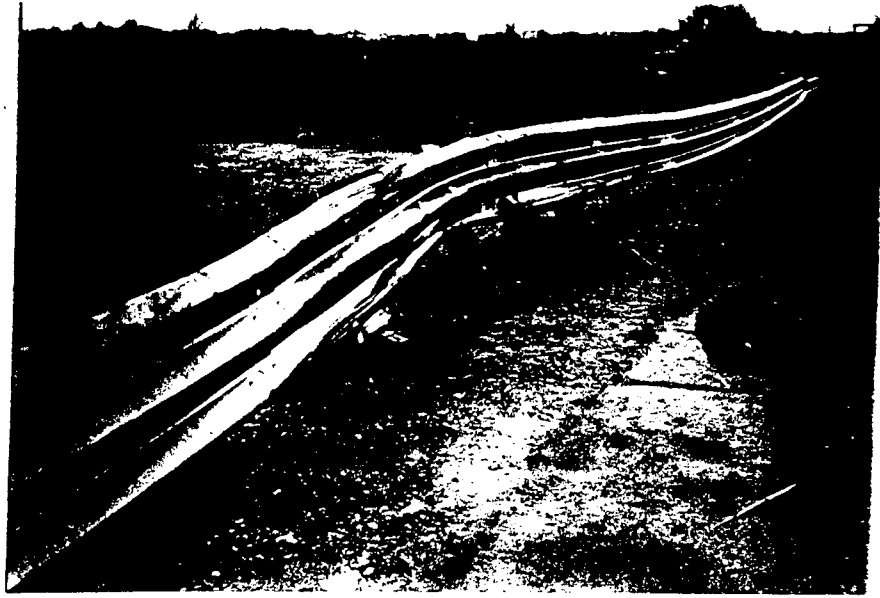
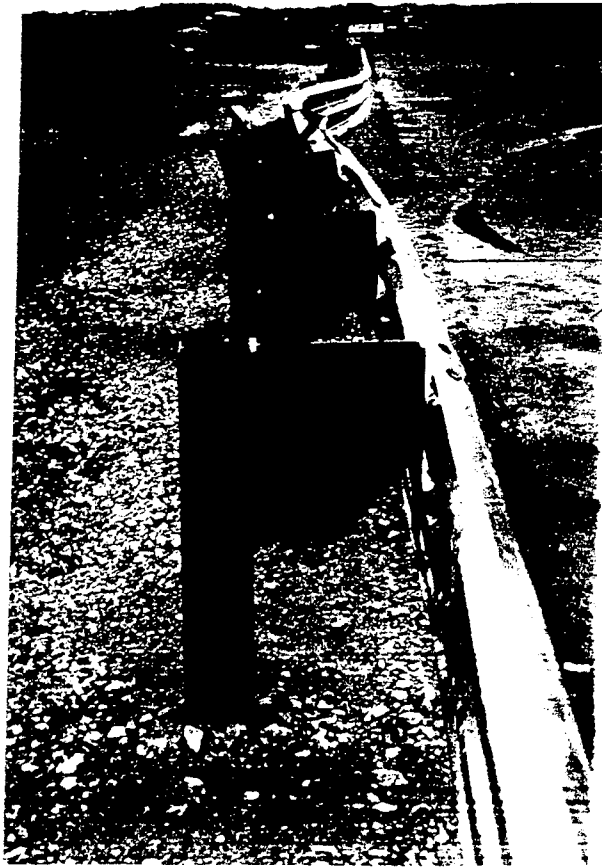
As seen in figures 124 through 128, the installation received moderate damage. There were tire marks on the face of the thrie-beam rail element from post 15 through post 19, and on

Figure 124. Modified three-beam galvanometer after test 471470-30.

the face of post 16 and the back side of post 17. The thrie-beam rail element was separated from post 17, and the flanges on post 17 showed evidence of wheel contact. Posts 16, 17, and 18 were twisted severely. The lateral deflections recorded at posts 14 through 20 are noted in table 7.

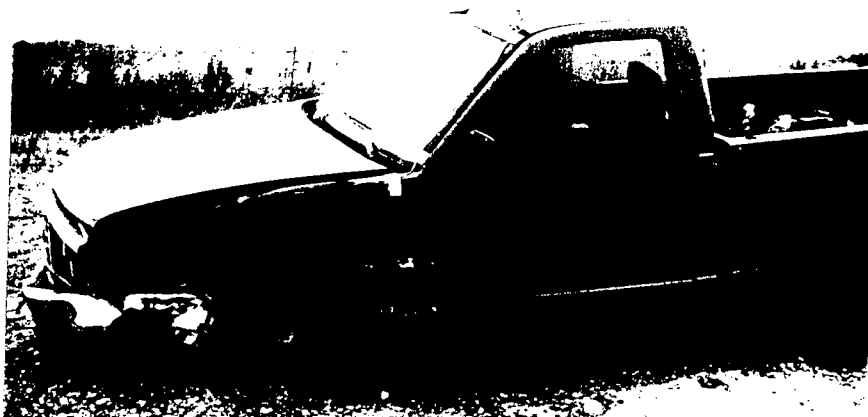
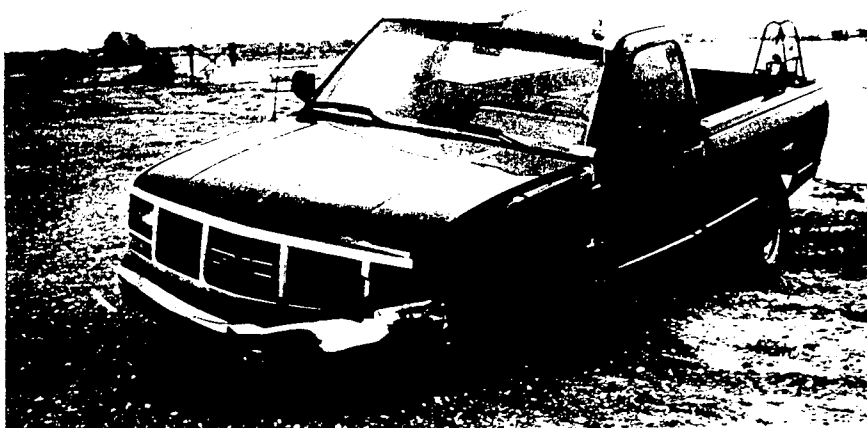
The vehicle sustained moderate damage, as shown in figure 129. The upper and lower A-arms, stabilizer bar, frame, tie rod ends, and spindle on the left side were damaged. The left front wheel assembly was torn from the vehicle's axle. The front bumper, grill, left front quarter panel, and both doors also were damaged. Maximum exterior crush at the left front corner of the vehicle was 430 mm (16.9 in) and there was deformation at the floorpan area of 16 mm (0.6 in).

Figure 129. Vehicle after test 471479-30

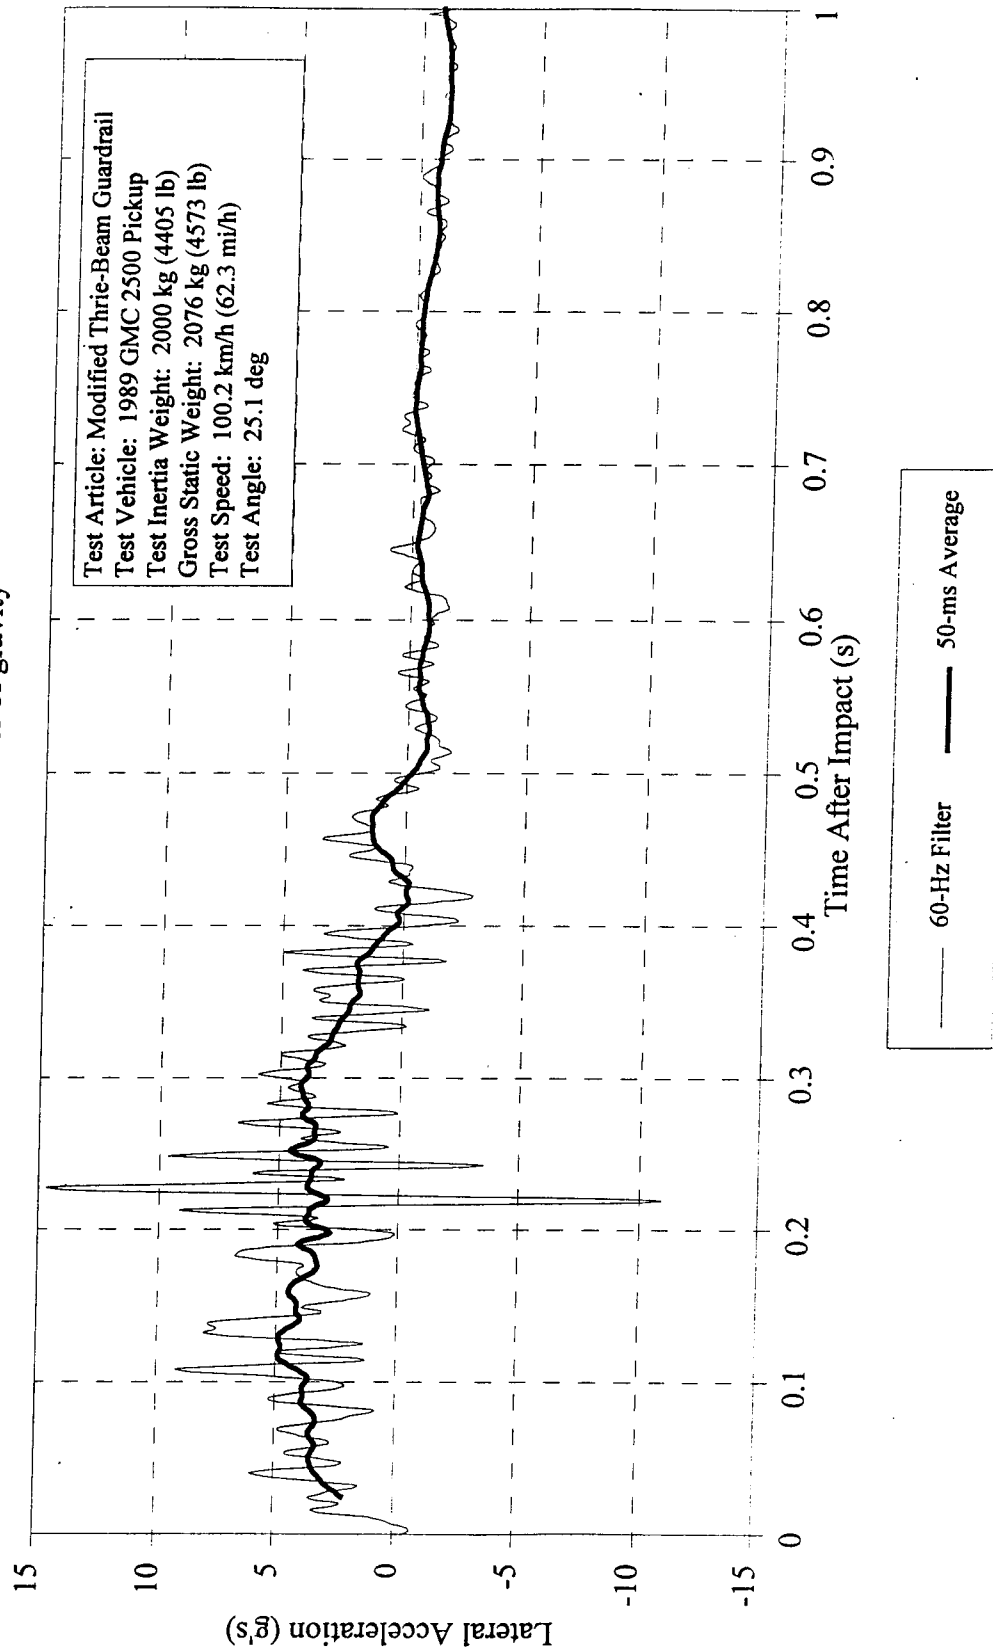
Figure 133. Vehicle lateral accelerometer trace for test 471470-30.

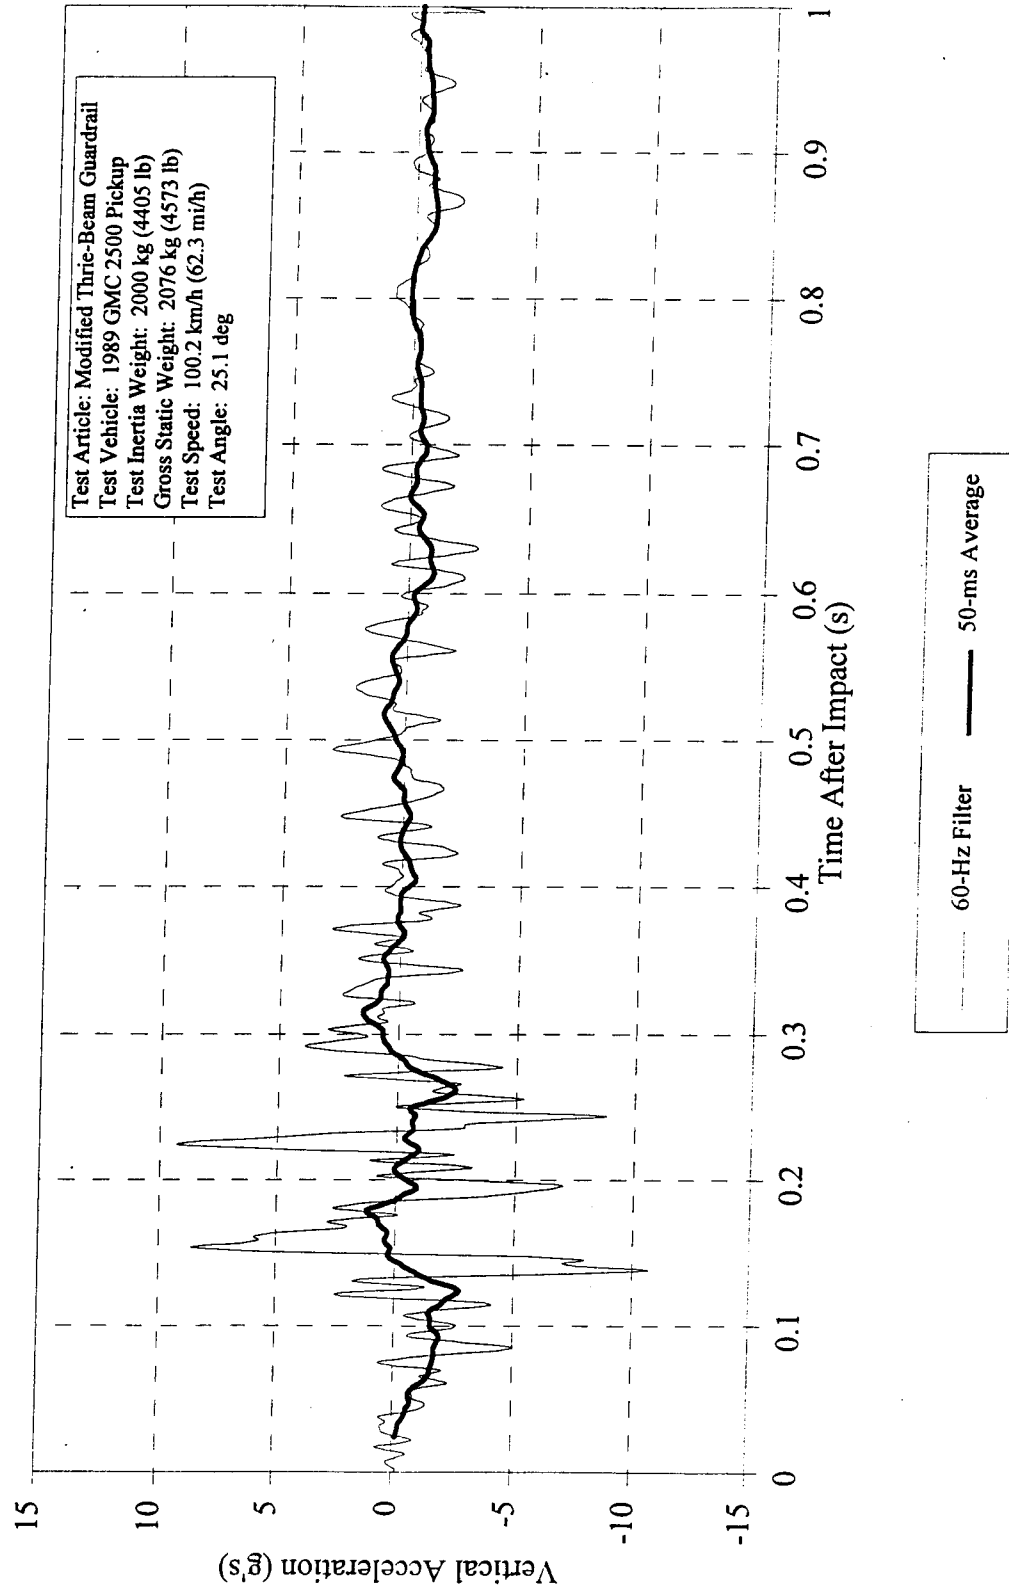
Figure 134. Vehicle vertical accelerometer trace for test 471470-30.
